Manhole Inspection Summary

Manhole # S33G__032MH

Insp Date: **8/14/08 11:08 AM**

Location Address: **101 w baltimore**

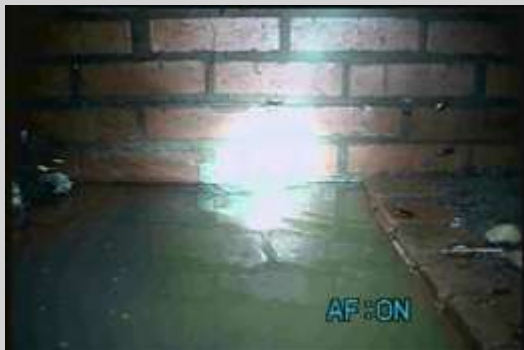
12 O'Clock Outflow

Pipe Height: 0 (in.) Direct

Pipe Material: **Clay** ☐ Pipe Lined

Invert Depth: **22.16** (ft.) Flow Characteristics: **Slow**

Deposits: ☒ None ☐ Mud ☐ Sludge ☐ Debris ☐ Grease

Infiltration: **None** Pipe Seal Cond: **Unknown**

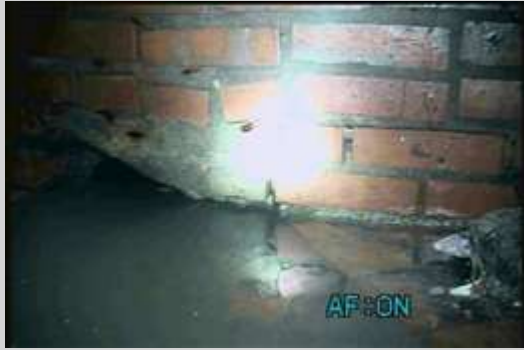
9 O'Clock Inflow

Pipe Height: 0 (in.) Direct

Pipe Material: **Clay** ☐ Pipe Lined

Infiltration: **None**
